EVALUATION OF PROTECTIVE COATINGS FOR CORRUGATED METAL PIPE

FINAL REPORT

73-05

MATERIALS AND RESEARCH DEPARTMENT

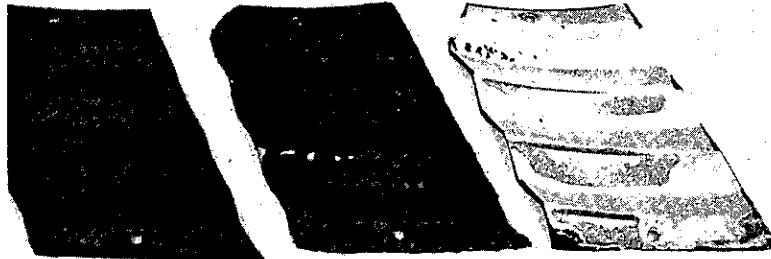
FIGURE 10

INITIAL ABRASION TEST SPECIMENS
 .018" Nexon (left), .075" Asphalt (center), and
 .018" Copoly-X Terrashield (right) all with
 174,312 revolutions at 3.65 fps, 3/8" x 1/2"
 coarse aggregate abrasive charge.

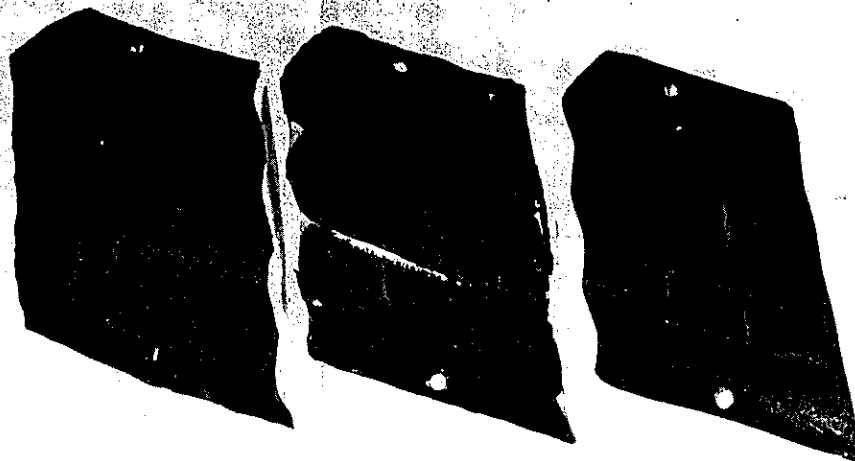
FIGURE 11

ABRASION TEST SPECIMENS

Asphalt (left), Pioneer Culvert Mastic (center) and Nexon (right) with 503,763 revolutions at 5 fps using minus No. 4 fine aggregate as an abrasive charge (see Table 3).

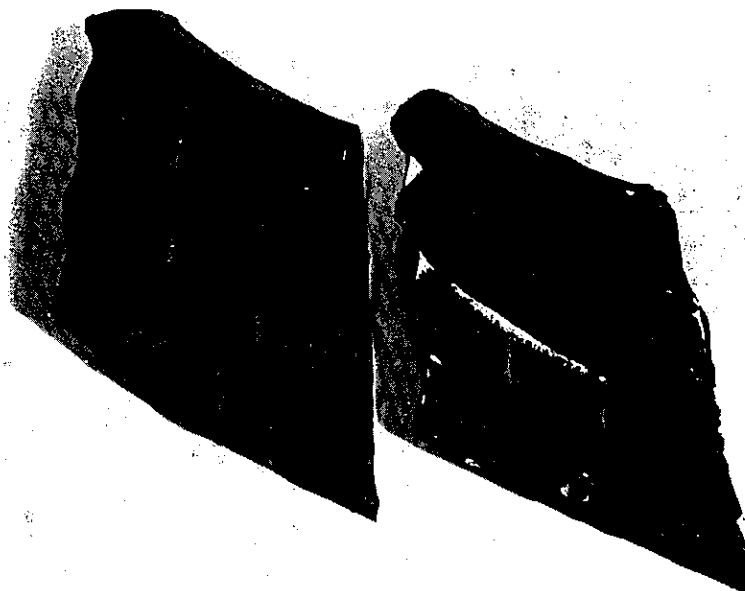
FIGURE 12

ABRASION TEST SPECIMENS

Asphalt (left) and Pioneer Culvert Mastic (right) (see Table 3)

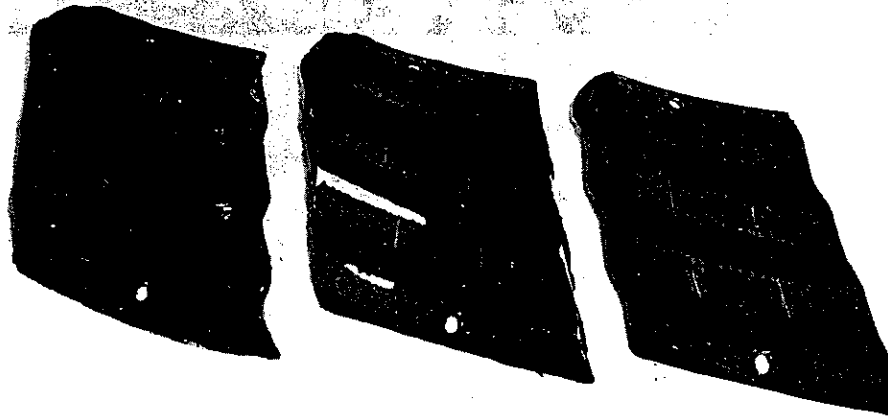
FIGURE 15

ABRASION TEST SPECIMENS

Asphalt (left) and Pioneer Culvert Mastic (center),
and Nexon (right), using minus No. 4 fine aggregate as
an abrasive charge (see Table 5).

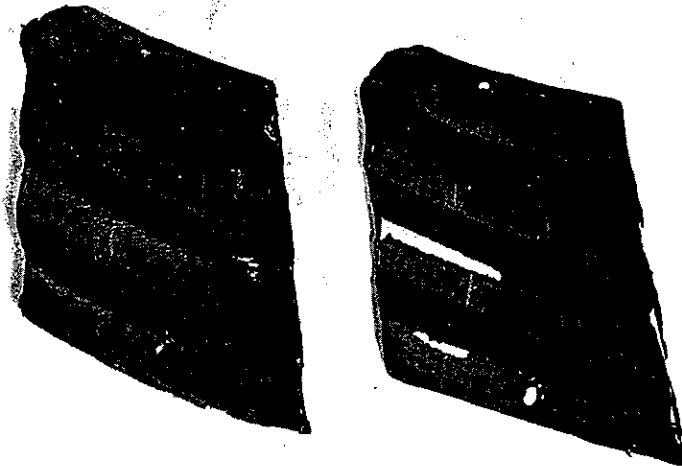
FIGURE 16

ABRASION TEST SPECIMENS

Asphalt (left) and Pioneer Culvert Mastic (right)
(see Table 5)

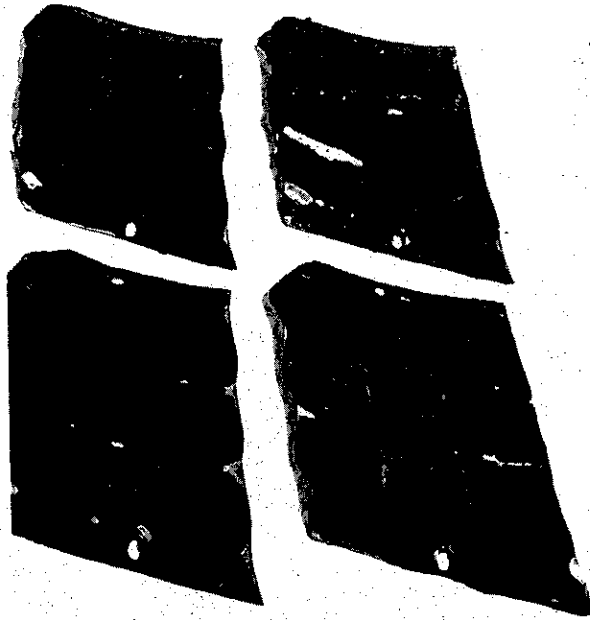
FIGURE 17.

Pioneer Culvert Mastic Abrasion Test Specimens
with 444,778 revolutions at 5 fps, using
minus 4 fine aggregate as an abrasive charge
(see Table 6)

From Table 6 Pioneer Culvert Mastic specimens were found to have individual thickness losses of .0103", .0262", .005", and .0105" per 444,778 revolutions. The average thickness loss for these four specimens is .013" and the average percent wear is 17.4.

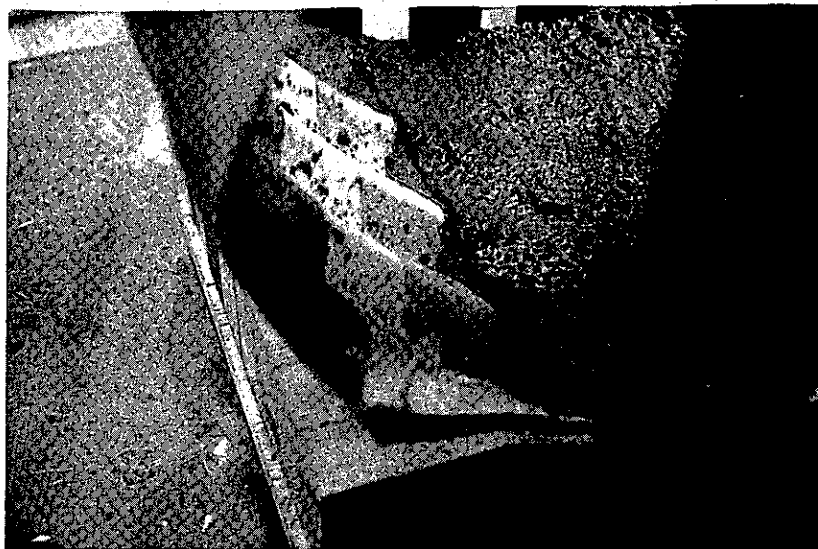
FIGURE 29

Close view of crack along Raceway specimen edge at .9 inches deflection during ring deflection test

Initial separation between the Raceway and pipe (small cracks about .010 inches in width) was noticed along the Raceway edges during the ring deflection tests. From 0 to .3 inches vertical deflection, no apparent changes took place. At .4 inches deflection, further separation of the Raceway from the pipe was observed. No other cracks were noticed on the outside or inside coating. At .5 inches deflection, cracking and separation along the Raceway border continued. No other visible cracks were present. At .6 inches deflection hairline cracks in the valleys of outside corrugations at mid-length of the pipe specimen and along the pipe sides had begun. Raceway cracking continued. At .7 inches deflection, the small cracks on the outside of the pipe had lengthened slightly. At .8 inches deflection, the small hairline cracks on the outside of the pipe (in valleys of corrugations) had increased in numbers. More cracks were apparent on one side than on the other. The thick Raceway coating had a fine crack down the center and along one corner through the entire thickness. At .9 inches deflection, more small cracks were noted on the sides with the condition of the Raceway being about the same.
